**HSG 264  
REINSPECTION OF ACMs**

***Norbury House Management Ltd  
The Office – Norbury House  
Friar Street  
Droitwich  
Worcestershire  
WR9 8EB***

***Norbury House  
Friar Street  
Droitwich  
Worcestershire  
WR9 8EB***

Project No. ABP/PQ25-00080/P-31913/04/25  
Report 1 (Revision 0)  
Report Issue Date: 20/05/2025

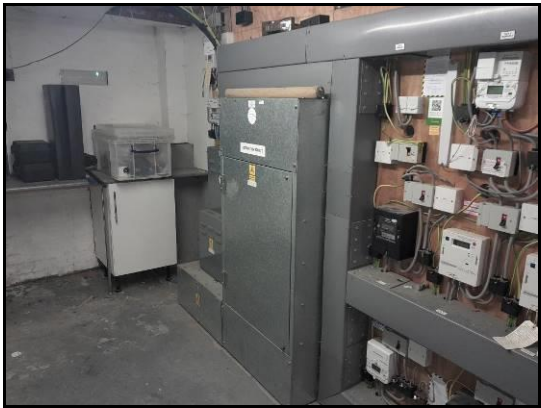
| | Location: | -1031<br>Basement |

| | Item Description: | Textile flash guards -<br>Textile |
| | Asbestos Type: | Chrysotile |

| <b>Norbury House – Re-inspection</b> | | |
|---|---|---|
| -1031 - Basement | Textile flash guards - Textile | Mark & Manage |

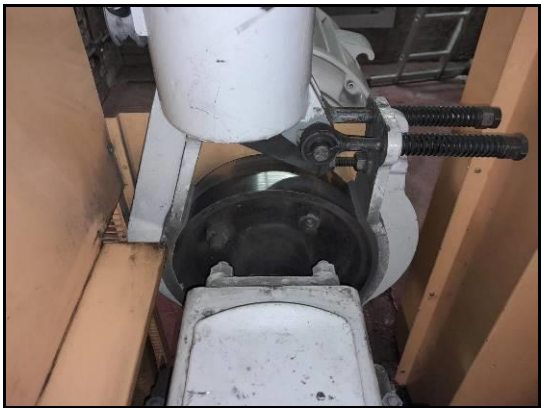
| | Location: | -1033<br>Lift Machine Room 1 |

| | Item Description: | Lift motor brake pads -<br>Composite |
| | Asbestos Type: | Chrysotile |

| <b>Norbury House – Re-inspection</b> | | |
|---|---|---|
| -1033 - Lift Machine Room 1 | Lift motor brake pads - Composite | Mark & Manage |

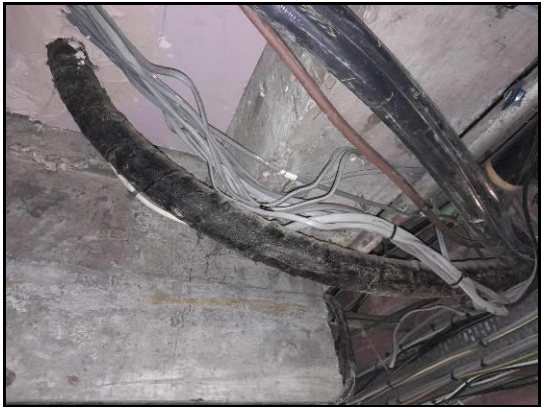
| | Location: | -1033<br>Lift Machine Room 1 |

| | Item Description: | Bitumen cable wrap -<br>Bitumen |
| | Asbestos Type: | Chrysotile |

| <b>Norbury House – Re-inspection</b> | | |
|---|---|---|
| -1033 - Lift Machine Room 1 | Bitumen cable wrap - Bitumen | Mark & Manage |

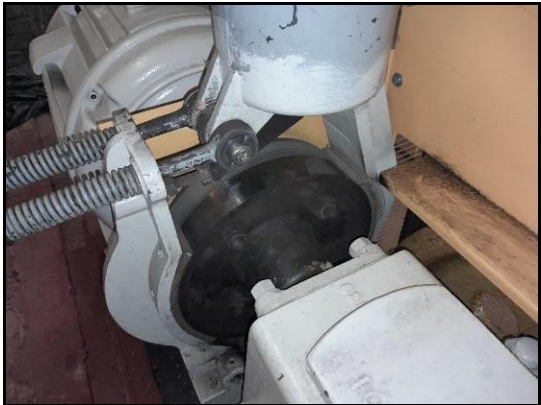
| | Location: | -1035<br>Lift Machine Room 2 |

| | Item Description: | Lift motor brake pads -<br>Composite |
| | Asbestos Type: | Chrysotile |

| <b>Norbury House – Re-inspection</b> | | |
|---|---|---|
| -1035 - Lift Machine Room 2 | Lift motor brake pads - Composite | Mark & Manage |

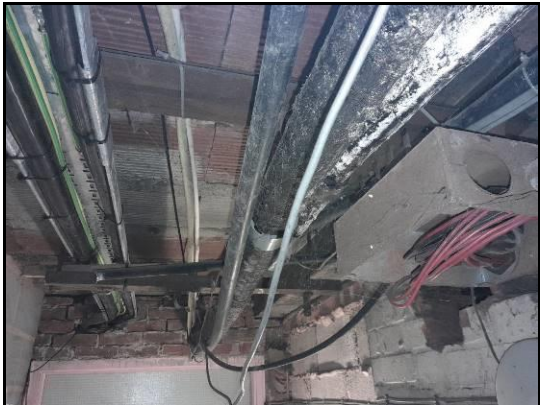
| | Location: | -1036<br>Basement |

| | Item Description: | Bitumen cable wrap -<br>Bitumen |
| | Asbestos Type: | Chrysotile |

| <b>Norbury House – Re-inspection</b> | | |
|---|---|---|
| -1036 - Basement | Bitumen cable wrap - Bitumen | Mark & Manage |

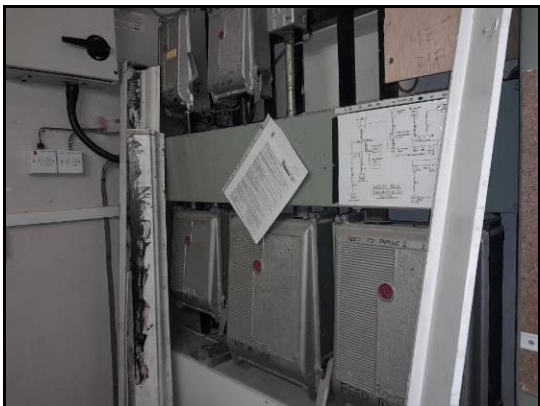
| | Location: | G023<br>Phase 1 electrical<br>meter room |

| | Item Description: | Textile flash guards -<br>Textile |
| | Asbestos Type: | Chrysotile |

| <b>Norbury House – Re-inspection</b> | | |
|---|---|---|
| G023 - Phase 1 electrical meter room | Textile flash guards - Textile | Mark & Manage |

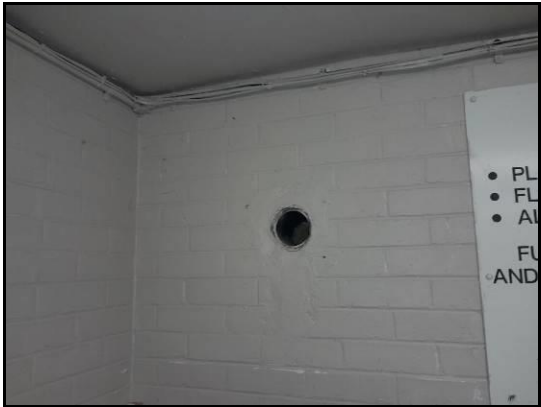
| | Location: | G030<br>Bin store |

| | Item Description: | Pipe sleeve - Cement |
| | Asbestos Type: | Chrysotile |

| <b>Norbury House – Re-inspection</b> | | |
|---|---|---|
| G030 - Bin store | Pipe sleeve - Cement | Mark & Manage |

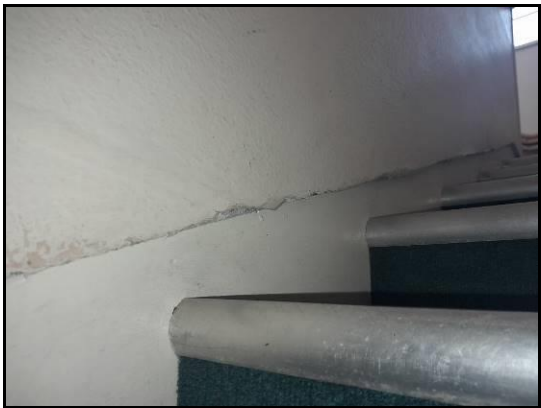
| | Location: | G087<br>Phase 2 lift lobby |

| | Item Description: | Lining panels to lift -<br>Insulating board |

| <b>Norbury House</b> | | |
|---|---|---|
| G087 - Phase 2 lift lobby | Lining panels to lift - Insulating board | Encapsulate (repair) |

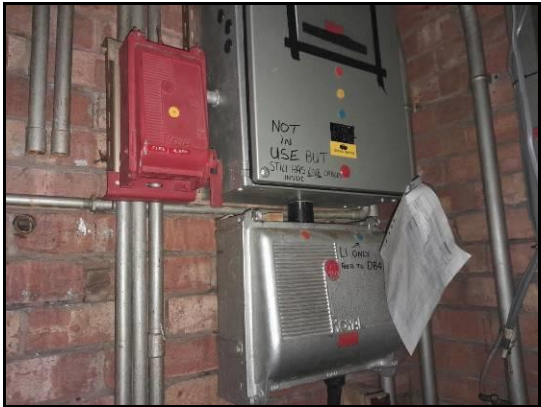
| | Location: | 1018<br>Phase 1 water meter cupboard |

| | Item Description: | Textiles flash guards to electrics - Textile |
| | Asbestos Type: | Chrysotile |

| <b>Norbury House – Re-inspection</b> | | |
|---|---|---|
| 1018 - Phase 1 water meter cupboard | Textiles flash guards to electrics - Textile | Mark & Manage |

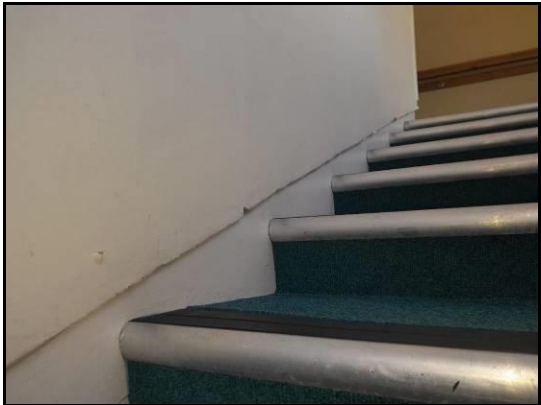
| | Location: | 1086<br>Phase 2 1st floor stairwell 1 |

| | Item Description: | Lining panels to lift - Insulating board |
| | Asbestos Type: | Crocidolite |

| <b>Norbury House</b> | | |
|---|---|---|
| 1086 - Phase 2 1st floor stairwell 1 | Lining panels to lift - Insulating board | Encapsulate (repair) |

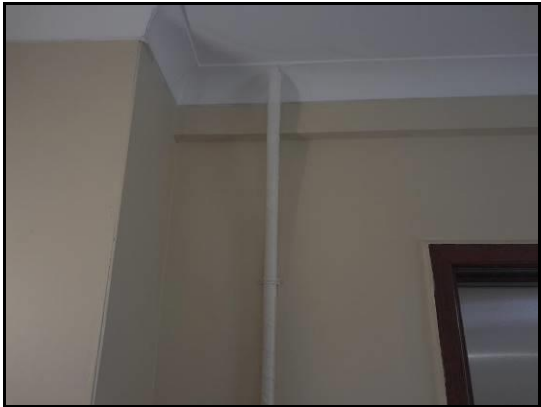
| | Location: | 2012<br>Phase 1 lift lobby |

| | Item Description: | Bitumen cable wrap -<br>Bitumen |
| | Asbestos Type: | Chrysotile |

| <b>Norbury House – Re-inspection</b> | | |
|---|---|---|
| 2012 - Phase 1 lift lobby | Bitumen cable wrap - Bitumen | Mark & Manage |

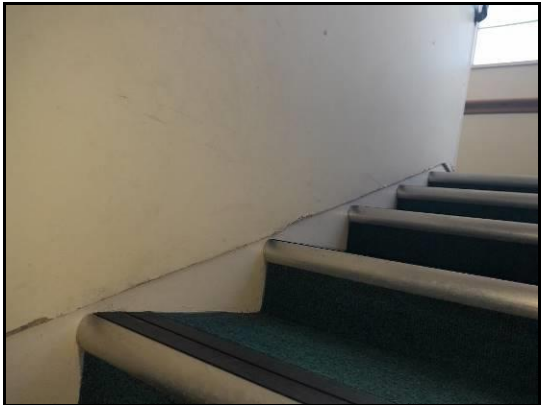
| | Location: | 2084<br>Phase 2 2nd floor<br>stairwell 1 |

| | Item Description: | Lining panels to lift -<br>Insulating board |
| | Asbestos Type: | Crocidolite |

| <b>Norbury House</b> | | |
|---|---|---|
| 2084 - Phase 2 2nd floor stairwell 1 | Lining panels to lift - Insulating board | Encapsulate (repair) |

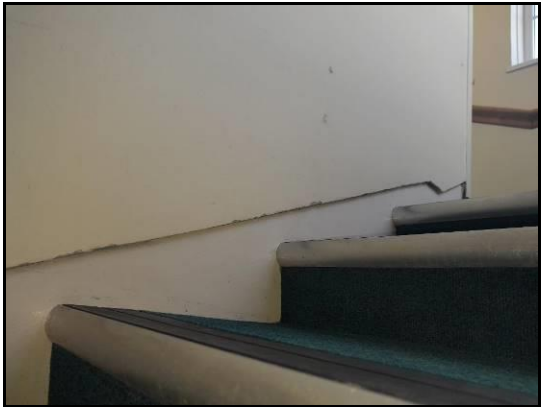
| | Location: | 3082<br>Phase 2 3rd floor<br>stairwell 1 |

| | Item Description: | Lining panels to lift -<br>Insulating board |
| | Asbestos Type: | Crocidolite |

| <b>Norbury House</b> | | |
|---|---|---|
| 3082 - Phase 2 3rd floor stairwell 1 | Lining panels to lift - Insulating board | Encapsulate (repair) |

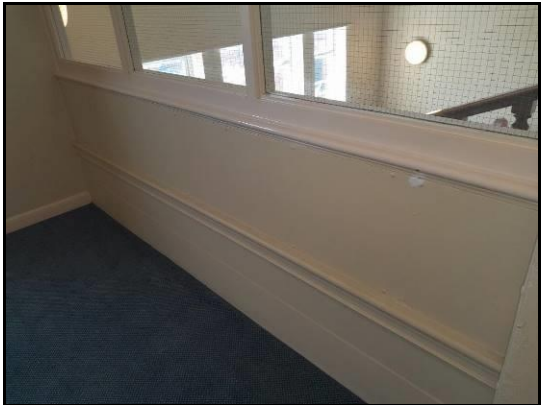
| | Location: | 4001<br>Phase 1 lift lobby |

| | Item Description: | Infill panels below<br>windows - Cement |
| | Asbestos Type: | Chrysotile |

| <b>Norbury House – Re-inspection</b> | | |
|---|---|---|
| 4001 - Phase 1 lift lobby | Infill panels below windows - Cement | Mark & Manage |

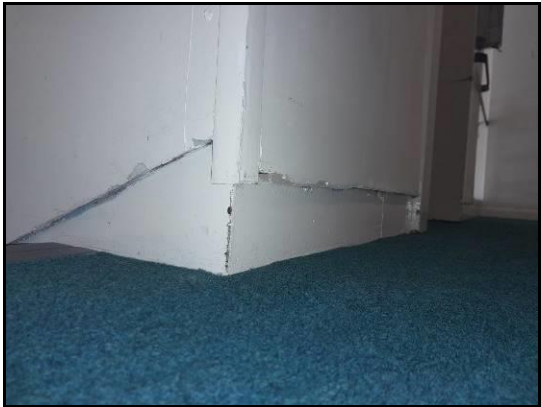
| | Location: | 4080<br>Phase 2 4th floor<br>stairwell 1 |

| | Item Description: | Lining panels to lift -<br>Insulating board |
| | Asbestos Type: | Crocidolite |

| <b>Norbury House</b> | | |
|---|---|---|
| 4080 - Phase 2 4th floor stairwell 1 | Lining panels to lift - Insulating board | Encapsulate (repair) |

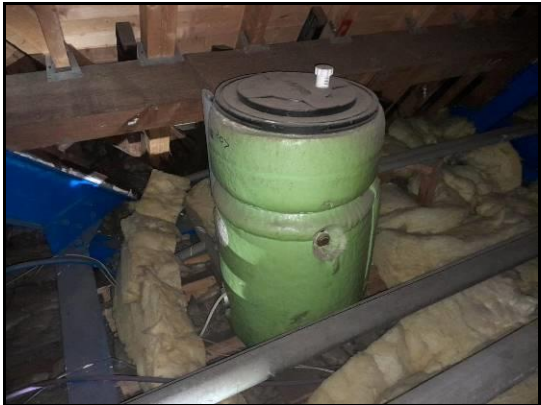
| | Location: | 5001<br>Roof void section 3 |

| | Item Description: | Gaskets sealed within<br>live tanks - Gasket |
| | Asbestos Type: | Chrysotile |

| <b>Norbury House – Re-inspection</b> | | |
|---|---|---|
| 5001 - Roof void section 3 | Gaskets sealed within live tanks - Gasket | Mark & Manage |

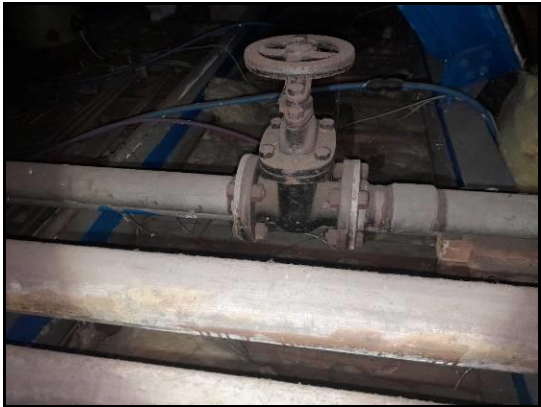
| | Location: | 5001<br>Roof void section 3 |

| | Item Description: | Gaskets sealed within pipe flanges - Gasket |
| | Asbestos Type: | Chrysotile |

| <b>Norbury House – Re-inspection</b> | | |
|---|---|---|
| 5001 - Roof void section 3 | Gaskets sealed within pipe flanges - Gasket | Mark & Manage |

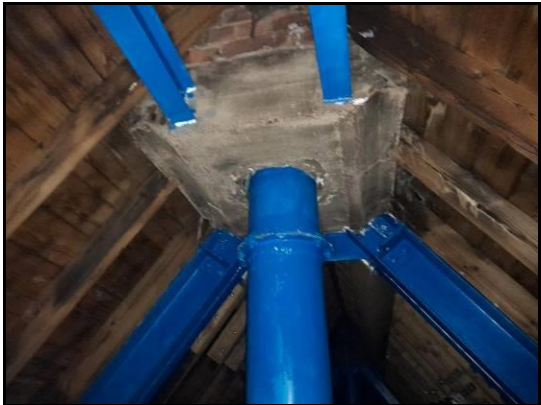
| | Location: | 5001<br>Roof void section 3 |

| | Item Description: | Gaskets sealed to vertical flue - Gasket |
| | Asbestos Type: | Chrysotile |

| <b>Norbury House – Re-inspection</b> | | |
|---|---|---|
| 5001 - Roof void section 3 | Gaskets sealed to vertical flue - Gasket | Mark & Manage |

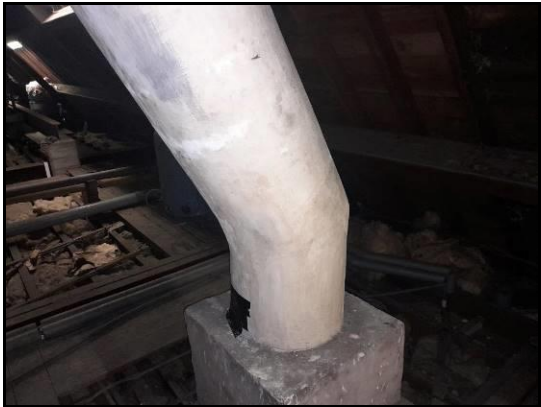
| | Location: | 5002<br>Roof void section 2 |

| | Item Description: | Lagging to vertical pipe - Lagging |
| | Asbestos Type: | Chrysotile |

| <b>Norbury House – Re-inspection</b> | | |
|---|---|---|
| 5002 - Roof void section 2 | Lagging to vertical pipe - Lagging | Mark & Manage |

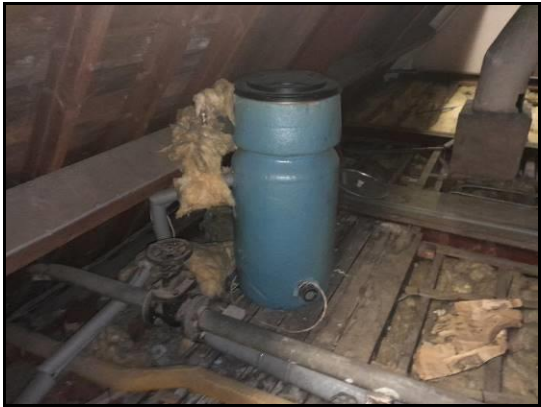
| | Location: | 5002<br>Roof void section 2 |

| | Item Description: | Gaskets sealed within live tanks - Gasket |
| | Asbestos Type: | Chrysotile |

| <b>Norbury House – Re-inspection</b> | | |
|---|---|---|
| 5002 - Roof void section 2 | Gaskets sealed within live tanks - Gasket | Mark & Manage |

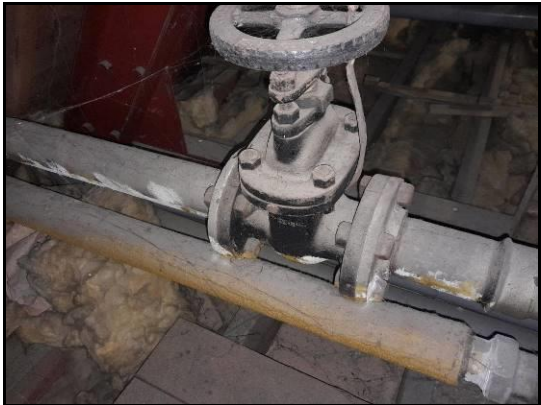
| | Location: | 5002<br>Roof void section 2 |

| | Item Description: | Gaskets sealed within pipe flanges - Gasket |
| | Asbestos Type: | Chrysotile |

| <b>Norbury House – Re-inspection</b> | | |
|---|---|---|
| 5002 - Roof void section 2 | Gaskets sealed within pipe flanges - Gasket | Mark & Manage |

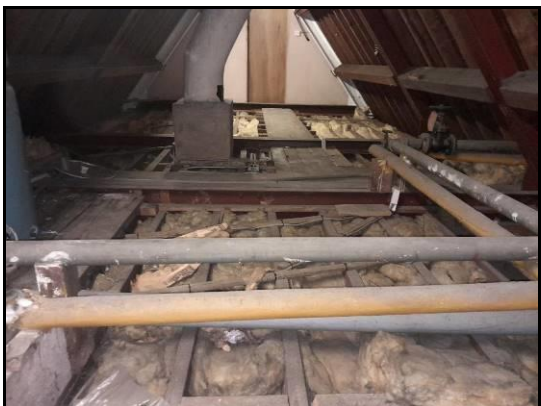
| | Location: | 5002<br>Roof void section 2 |

| | Item Description: | Debris to all surface areas - Debris |
| | Asbestos Type: | Chrysotile |

| <b>Norbury House</b> | | |
|---|---|---|
| 5002 - Roof void section 2 | Debris to all surface areas - Debris | Remove |

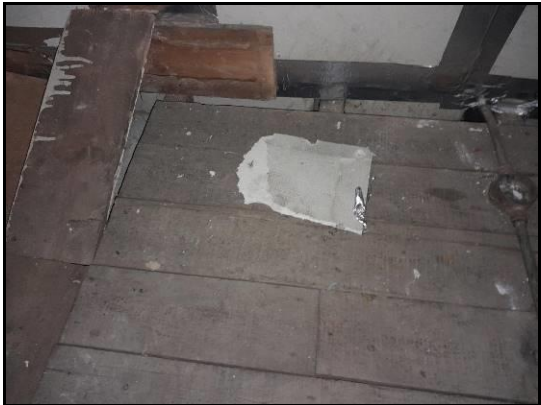
| | Location: | 5003<br>Roof void section 1 |

| | Item Description: | Debris to all surface areas - Debris |
| | Asbestos Type: | Amosite |

| <b>Norbury House</b> | | |
|---|---|---|
| 5003 - Roof void section 1 | Debris to all surface areas - Debris | Remove |

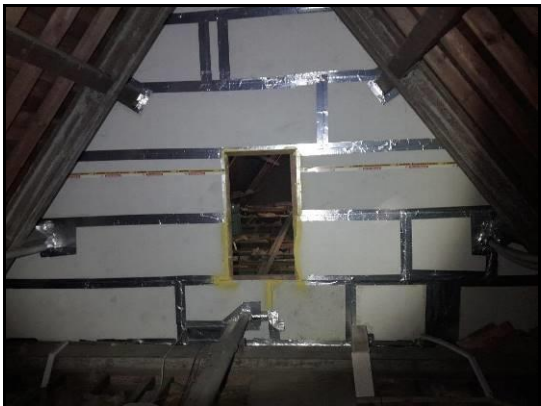
| | Location: | 5003<br>Roof void section 1 |

| | Item Description: | Insulating board wall barrier - Debris |
| | Asbestos Type: | Amosite |

| <b>Norbury House</b> | | |
|---|---|---|
| 5003 - Roof void section 1 | Insulating board wall barrier - Debris | Remove |

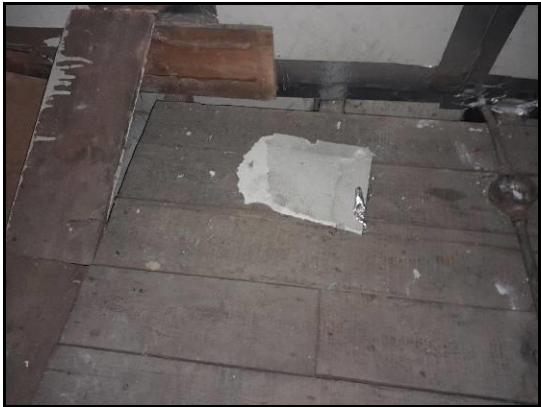
| | Location: | 5003<br>Roof void section 1 |

| | Item Description: | Debris throughout -<br>Debris |
| | Asbestos Type: | Amosite |

| <b>Norbury House</b> | | |
|---|---|---|
| 5003 - Roof void section 1 | Debris throughout - Debris | Remove |

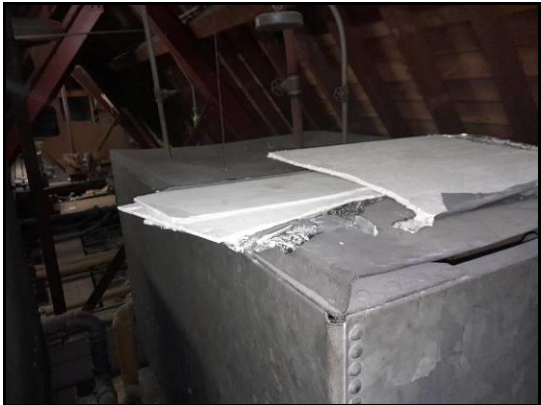
| | Location: | 5003<br>Roof void section 1 |

| | Item Description: | Redundant panel to<br>metal water tank -<br>Insulating board |
| | Asbestos Type: | Amosite |

| <b>Norbury House</b> | | |
|---|---|---|
| 5003 - Roof void section 1 | Redundant panel to metal water tank - Insulating board | Remove |

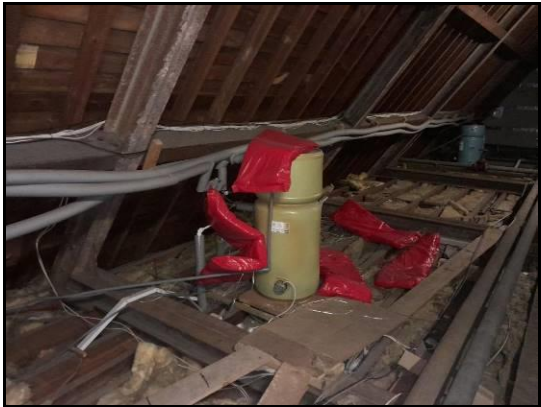
| | Location: | 5003<br>Roof void section 1 |

| | Item Description: | Gaskets sealed within live tanks - Gasket |
| | Asbestos Type: | Chrysotile |

| <b>Norbury House – Re-inspection</b> | | |
|---|---|---|
| 5003 - Roof void section 1 | Gaskets sealed within live tanks - Gasket | Mark & Manage |

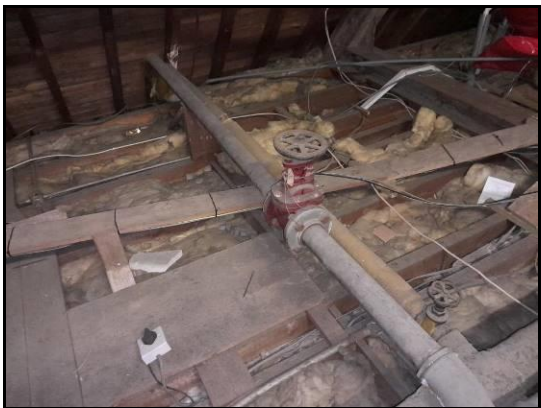
| | Location: | 5003<br>Roof void section 1 |

| | Item Description: | Gaskets sealed within pipe flanges - Gasket |
| | Asbestos Type: | Chrysotile |

| <b>Norbury House – Re-inspection</b> | | |
|---|---|---|
| 5003 - Roof void section 1 | Gaskets sealed within pipe flanges - Gasket | Mark & Manage |

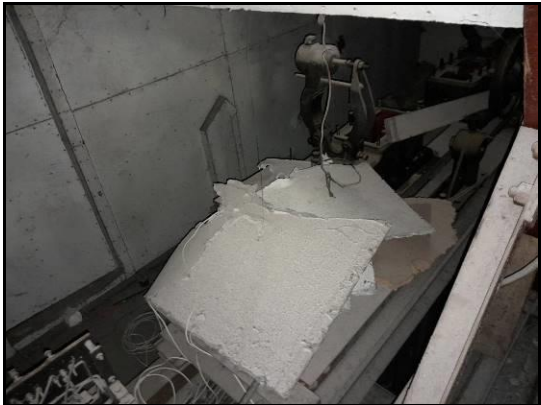
| | Location: | 5003<br>Roof void section 1 |

| | Item Description: | Insulating board debris<br>to floor and surfaces -<br>Insulating board |
| | Asbestos Type: | Amosite |

| <b>Norbury House</b> | | |
|---|---|---|
| 5003 - Roof void section 1 | Insulating board debris to floor and surfaces - Insulating board | Remove |

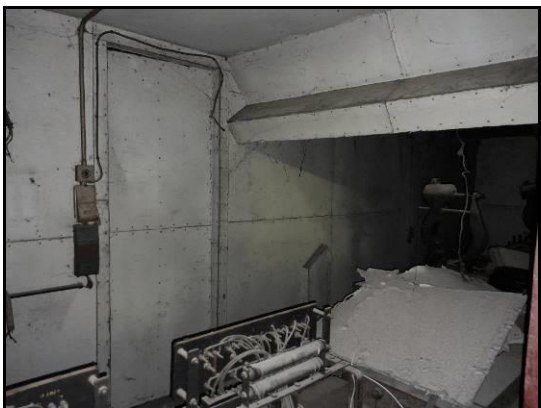
| | Location: | 5003<br>Roof void section 1 |

| | Item Description: | Insulating board lining<br>- Insulating board |
| | Asbestos Type: | Amosite |

| <b>Norbury House</b> | | |
|---|---|---|
| 5003 - Roof void section 1 | Insulating board lining - Insulating board | Remove |

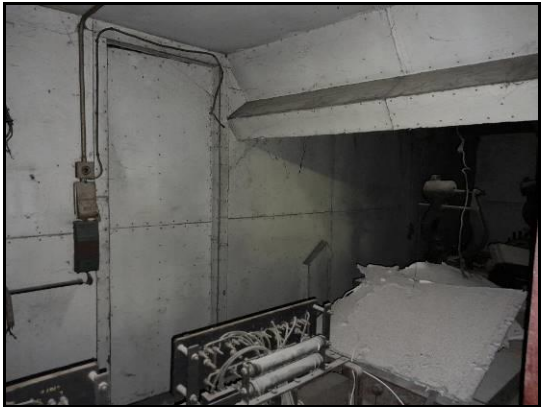
| | Location: | 5003<br>Roof void section 1 |

| | Item Description: | Insulating board lining<br>- Insulating board |
| | Asbestos Type: | Amosite |

| <b>Norbury House</b> | | |
|---|---|---|
| 5003 - Roof void section 1 | Insulating board lining - Insulating board | Remove |

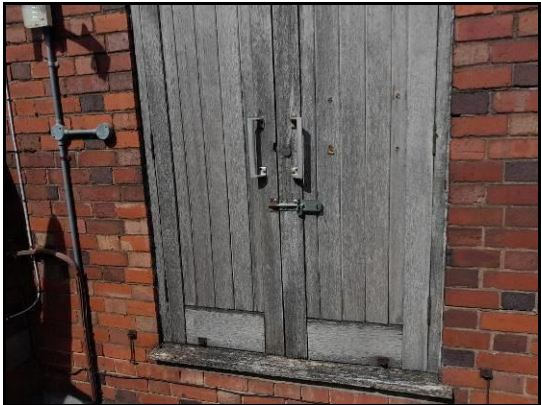
| | Location: | EX065<br>Phase 2 lift motor room |

| | Item Description: | Mastic to timber<br>framework - Putty |

| <b>Norbury House – Re-inspection</b> | | |
|---|---|---|
| EX065 - Phase 2 lift motor room | Mastic to timber framework - Putty | Mark & Manage |

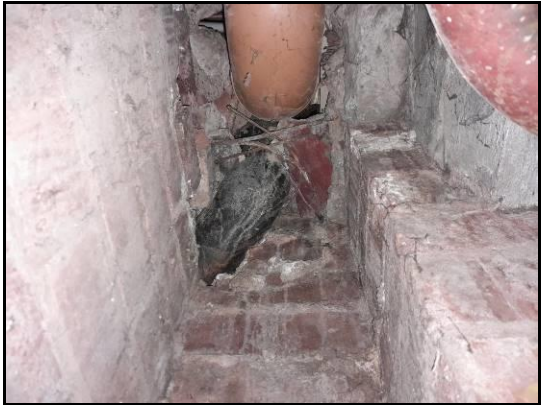
| | Location: | -1033<br>Lift Machine Room 1 |

| | Item Description: | Cement tile shuttering -<br>Cement |
| | Asbestos Type: | Chrysotile |

| <b>Norbury House - Management</b> | | |
|---|---|---|
| -1033 - Lift Machine Room 1 | Cement tile shuttering - Cement | Mark & Manage |

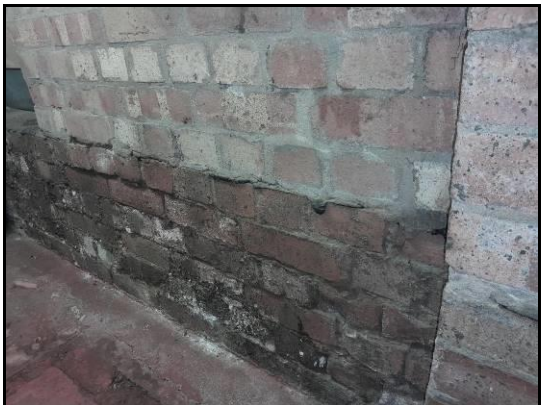
| | Location: | -1033<br>Lift Machine Room 1 |

| | Item Description: | Damp proof course -<br>Bitumen |
| | Asbestos Type: | No asbestos detected |

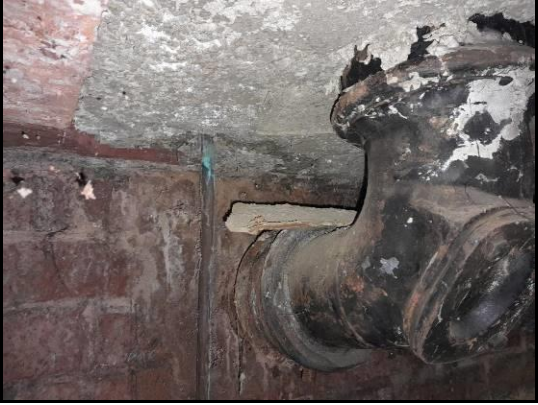
| | Location: | -1035<br>Lift Machine Room 1 |

| | Item Description: | Insulating board<br>shuttering - Insulating<br>board |
